Manhole Inspection Summary

Manhole # S13AA1018MH

Insp Date: **1/26/09 10:34 AM**

Location Address: **3003 SPRINGHILL AVE** Cross Street: **TOWANDA AVE**

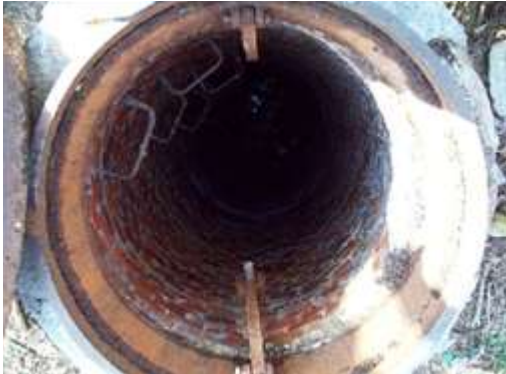
Defect 2

Frame Offset: **2** (in.) Condition: ☒ Sound ☐ Cracked ☐ Leaks

FRAME OFFSET

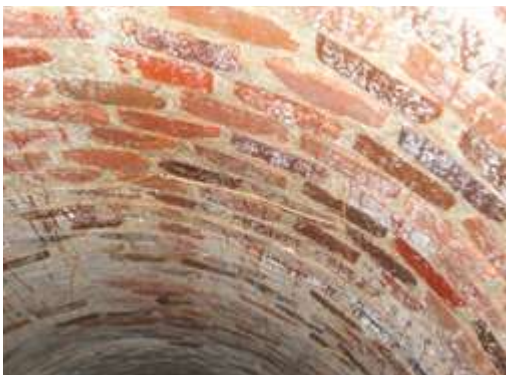
Chimney / Frame Adjustment ☒ Exists Material: **Brick** ☐ Parged Height: **0** (in.)
Condition: ☐ Sound ☐ Cracked ☒ **Root Intrusion** ☐ Loose Brick ☐ Deteriorated
Infiltration: ☐ None ☐ Joint ☐ Cracks ☐ Mortar ☒ **Roots** ☐ Wall

Corbel Material: **Brick** ☐ Parged Type: **Concentric/Eccentric**
Condition: ☐ Sound ☐ Cracked ☒ **Root Intrusion** ☐ Loose Brick ☐ Deteriorated
Infiltration: ☐ None ☐ Joint ☐ Cracks ☐ Mortar ☒ **Roots** ☐ Wall

INFILTRATION OF ROOTS ON BARREL AND CHIMNEY

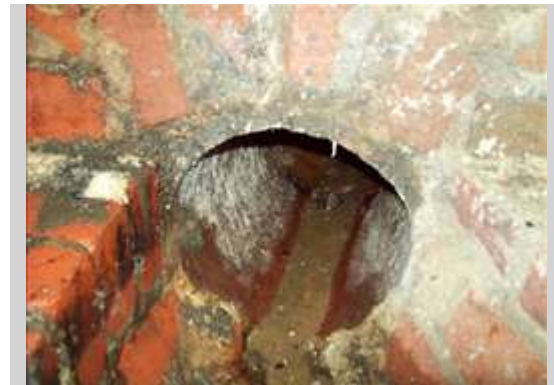
Drop In @ 6 O'Clock

Drop: **Outside Direct**
Angled: Reading: (ft.)
Inv Depth: **23.82** (ft.)
Drop Condition: **Partly Clogged**

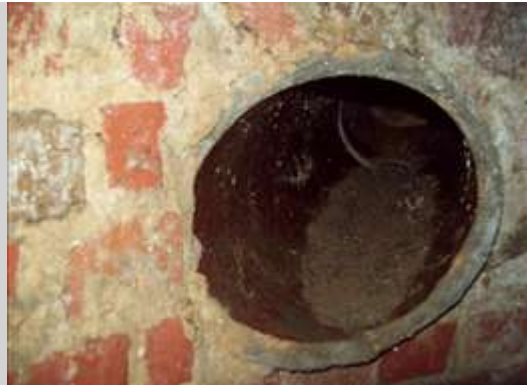
9 O'Clock Inflow

Deposits: ☐ None ☐ Mud ☐ Sludge ☒ **Debris** ☐ Grease

Silt Depth: **1** (in.) Deposits Extent: **Light**
